Annex 8. Visual examples of incompliances to TMF safety operation and protective measures

The photos below collected by Prof. D. Pikarenia and Prof. O. Orlinskaya demonstrated safety deficiencies at different parts of the TMF including

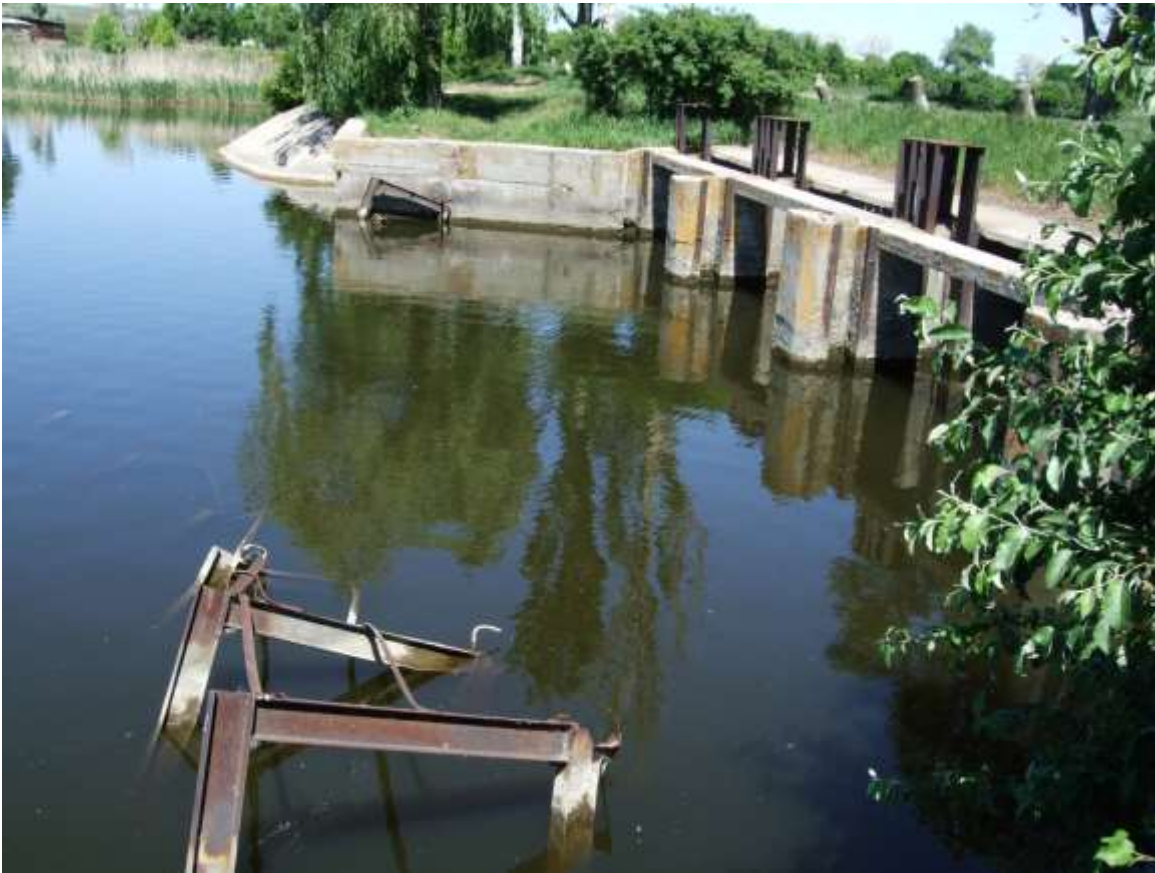
Figure A8.1: Spillway of tunnel type. Protective spillway grid is destroyed as a result of vandalism

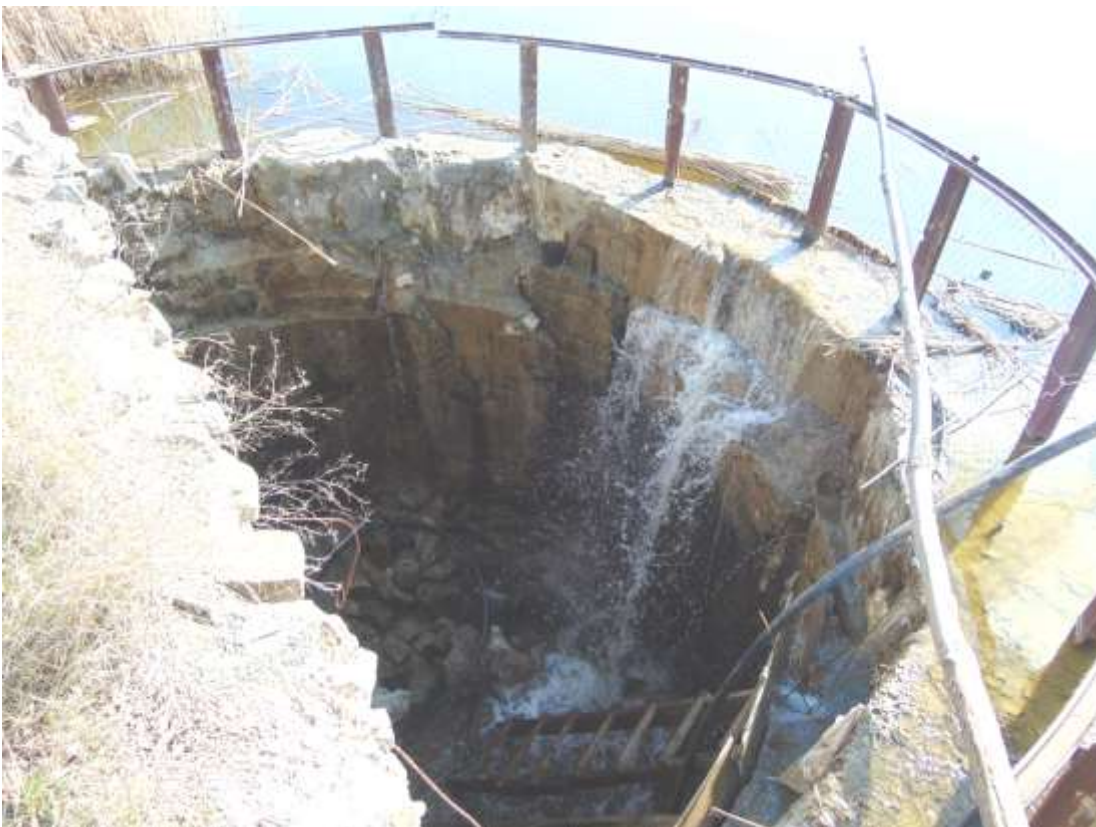
Figure A8.2: Spillway of mine type. Clogged shaft causes overflow through the dam

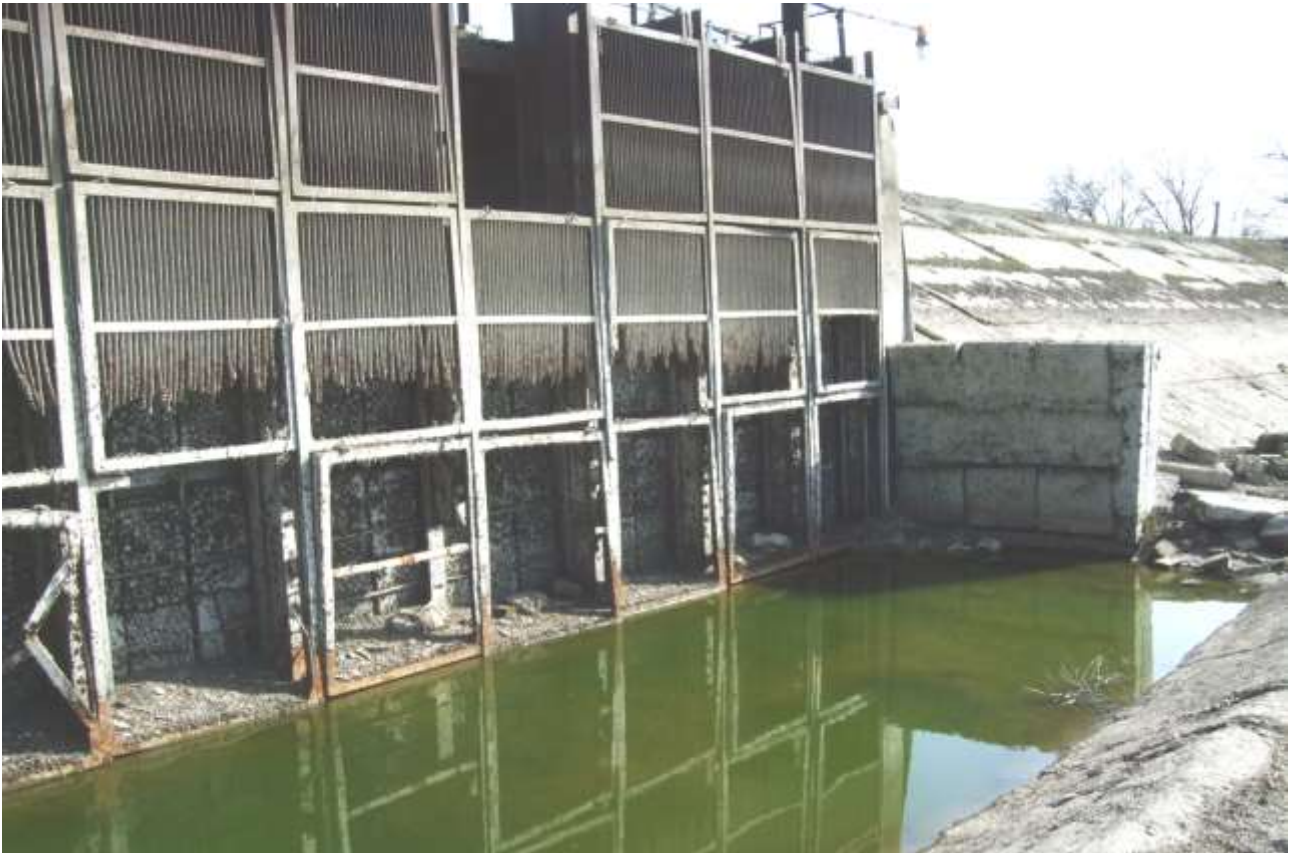
Figure A8.3: Spillway of mine type. Protective grid was destroyed by corrosion; as a result the spillway does not function.

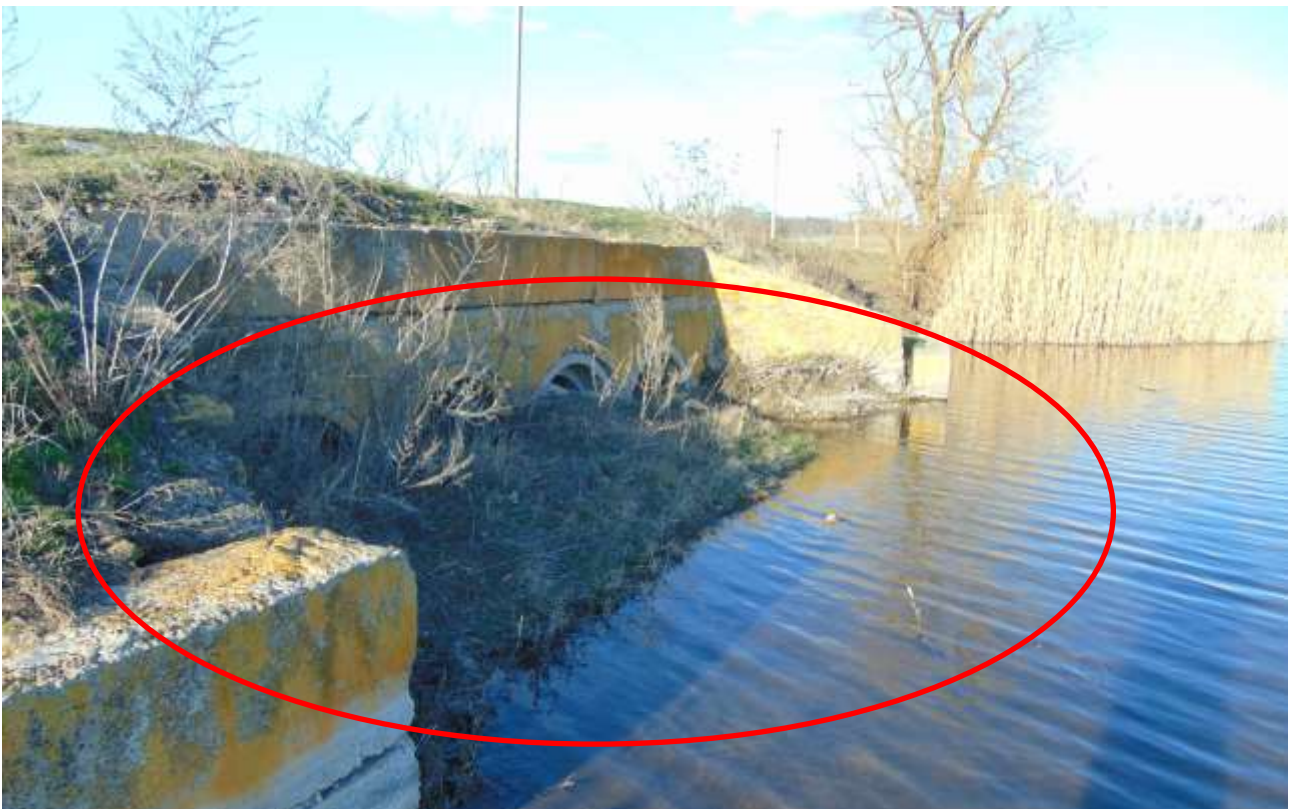
Figure A8.4: Emergency tailings spillway with the inlets blocked by sediments.

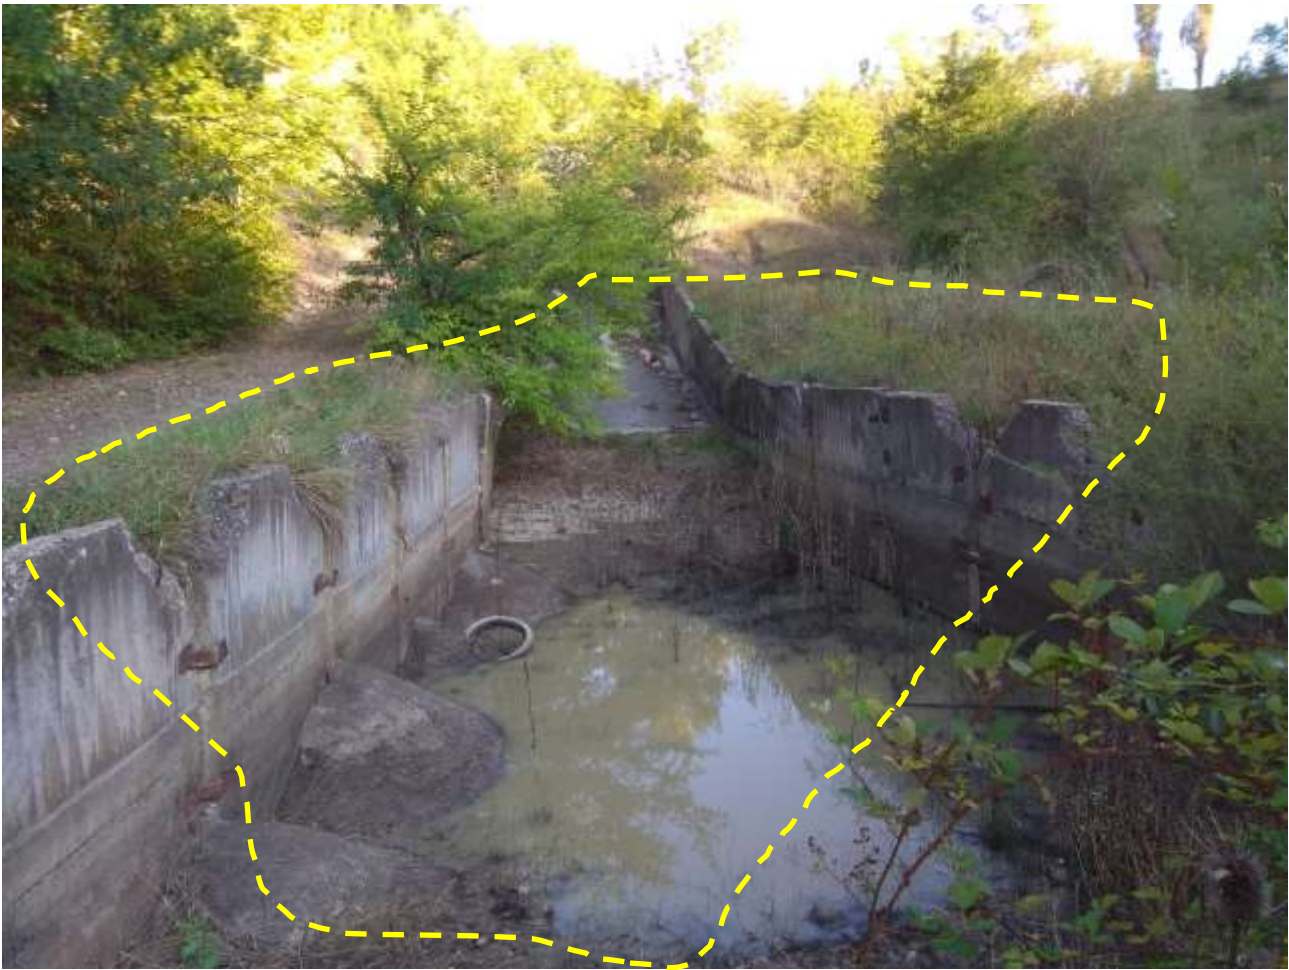
Figure A8.5: The clogged channel of the tailing pond prevents full water evacuation

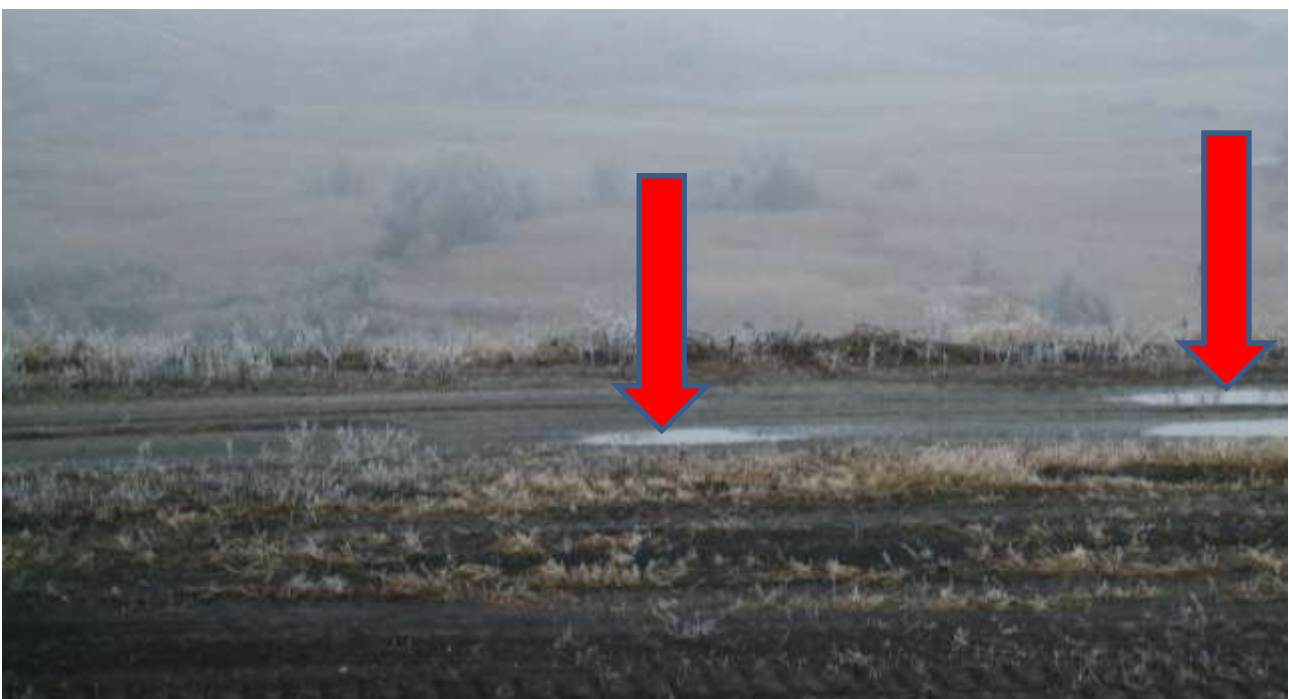
Figure A8.6: The third upper ledge of the tailings dam. Excessive waterlogging of the dam, atmospheric precipitation is not absorbed (View from the second ledge)

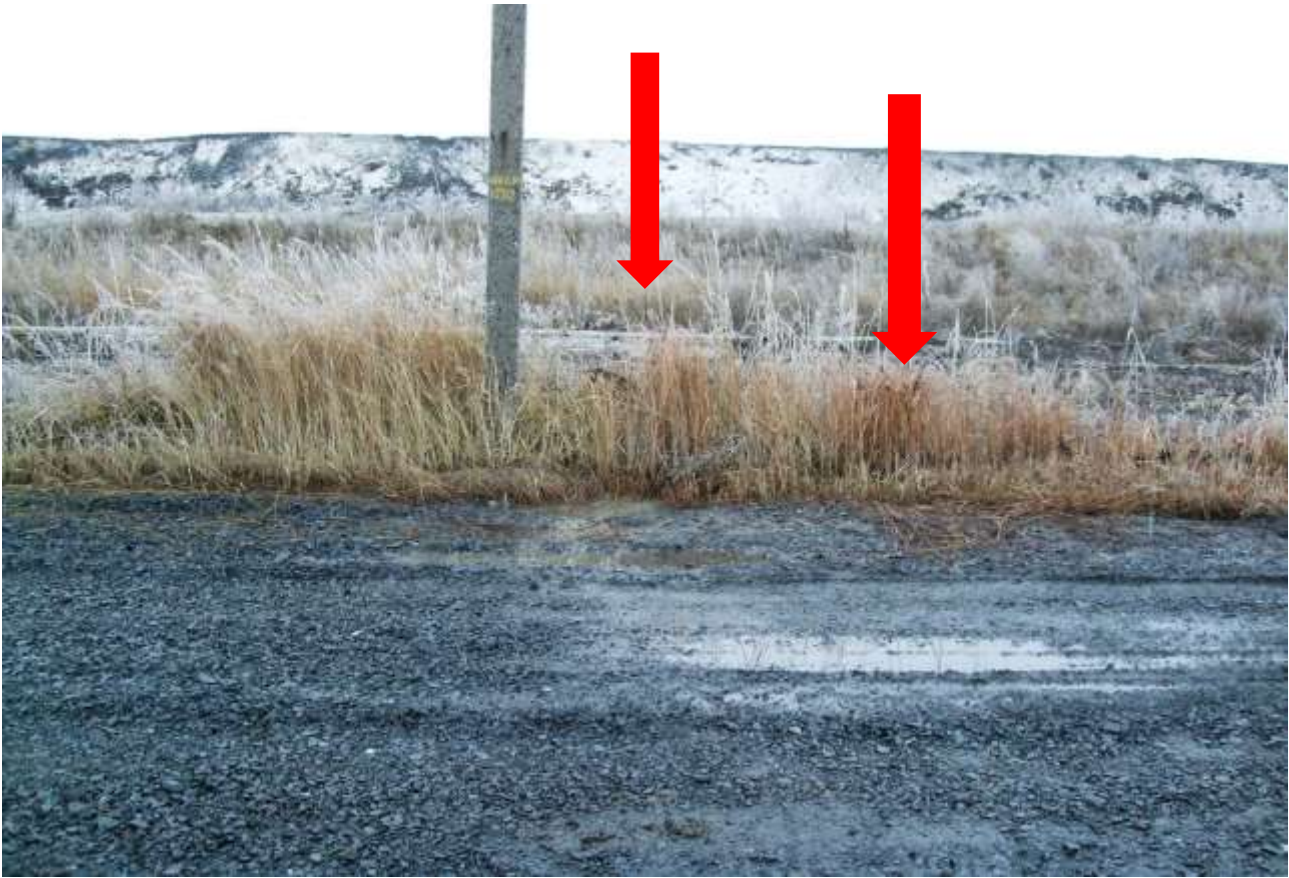
Figure A8.7: The second upper ledge of the tailings dam. Growth of water-resistant plants can be interpreted as the implicit sign of seepage

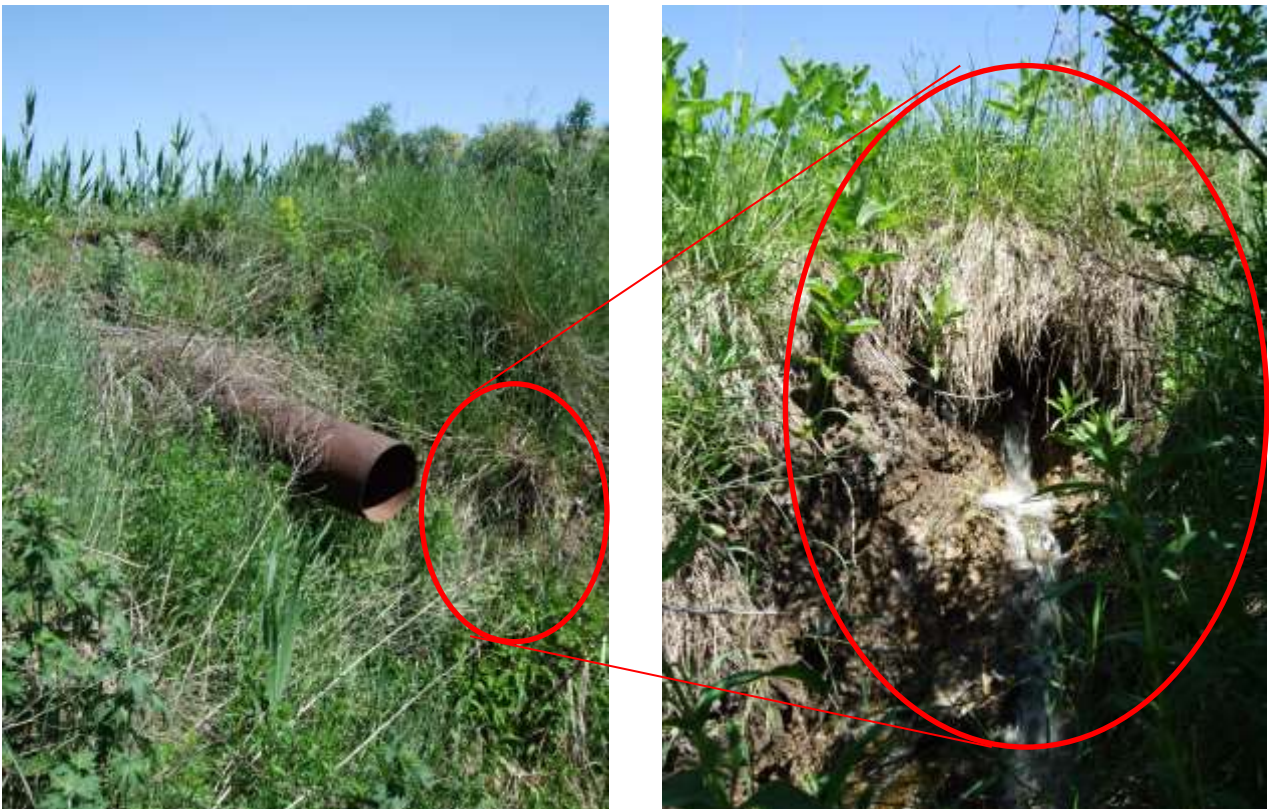
Figure A8.8: External slope of the dam. Water leaks and flows aside the spillway

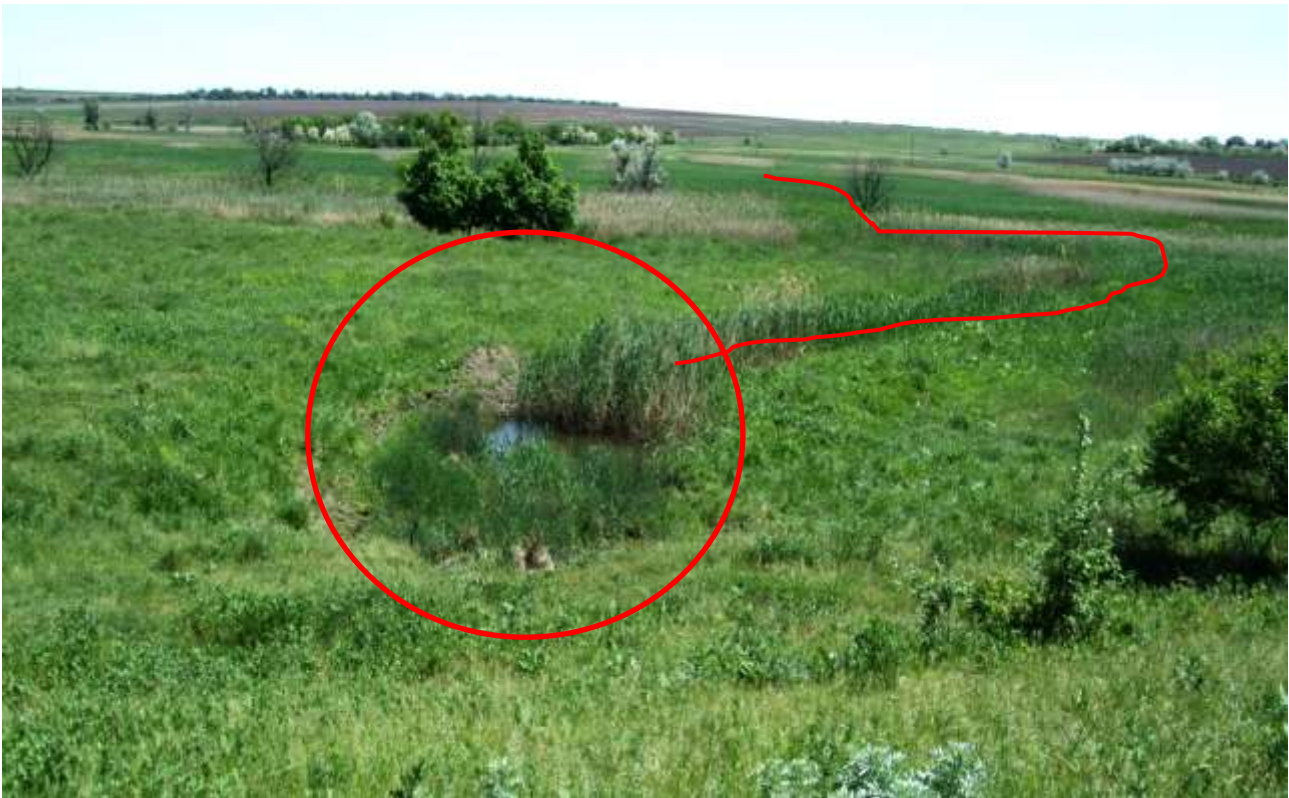
Figure A8.9: Bottom-line of the tailings dam. Seepage through the dam and outlet is identified as a spring (View from the dam)

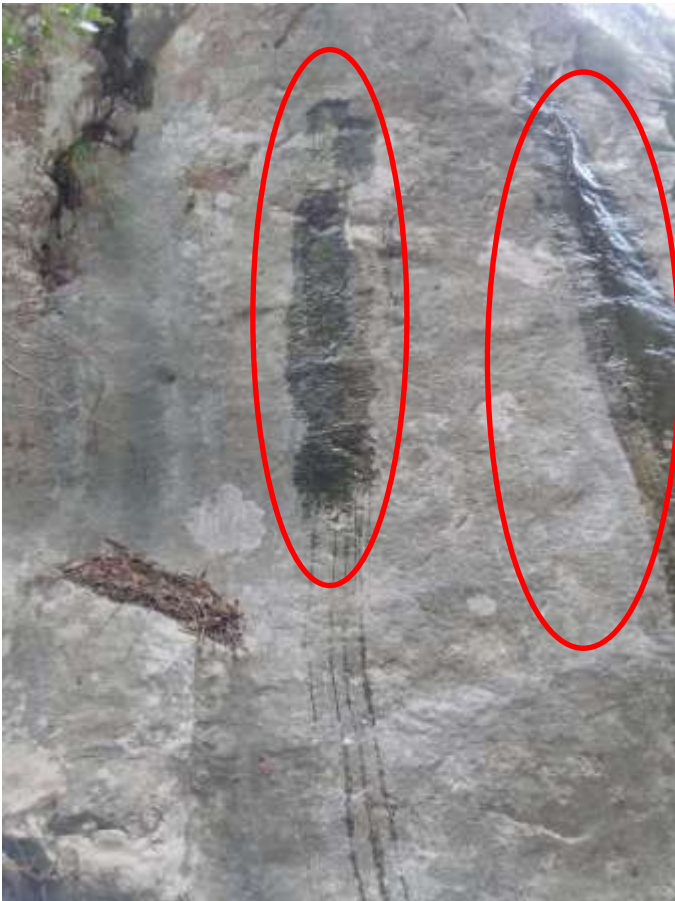
Figure A8.10: Concrete tailings dam. Seepage through the pores in the monolith is visible as "tears".

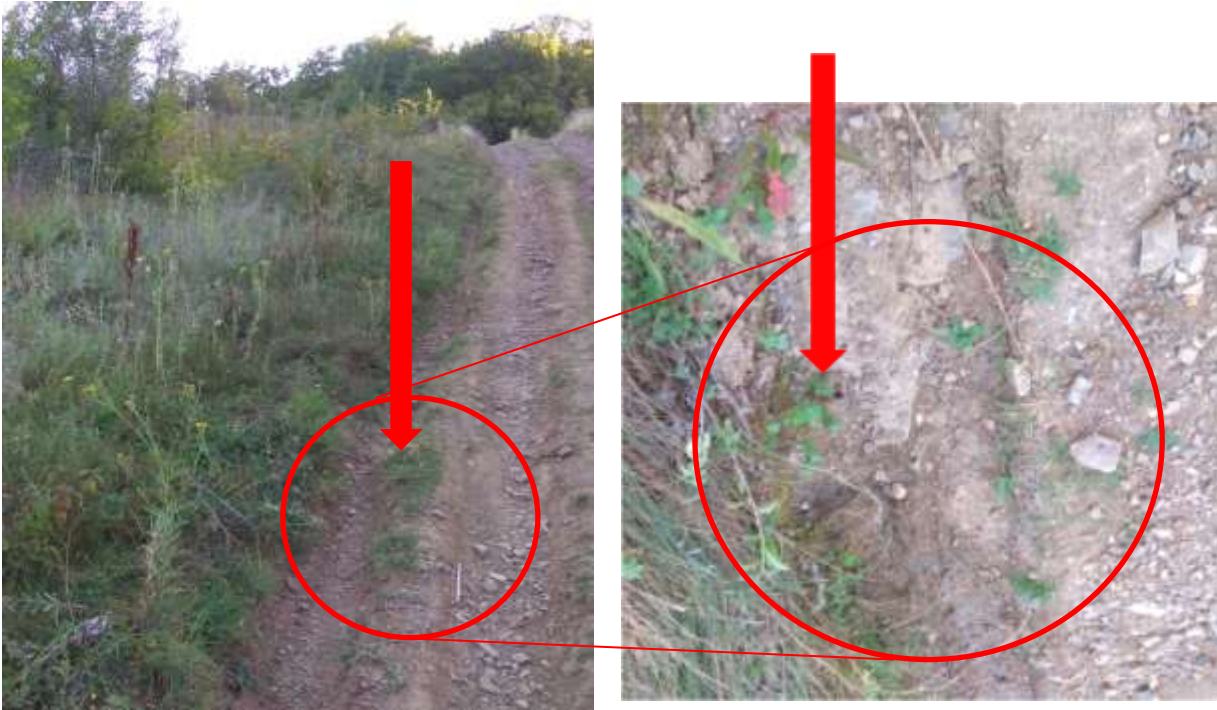
Figure A8.11: Central part of the external slope of the tailings dam. Seepage is identified in the form of spots of soil moisturizing

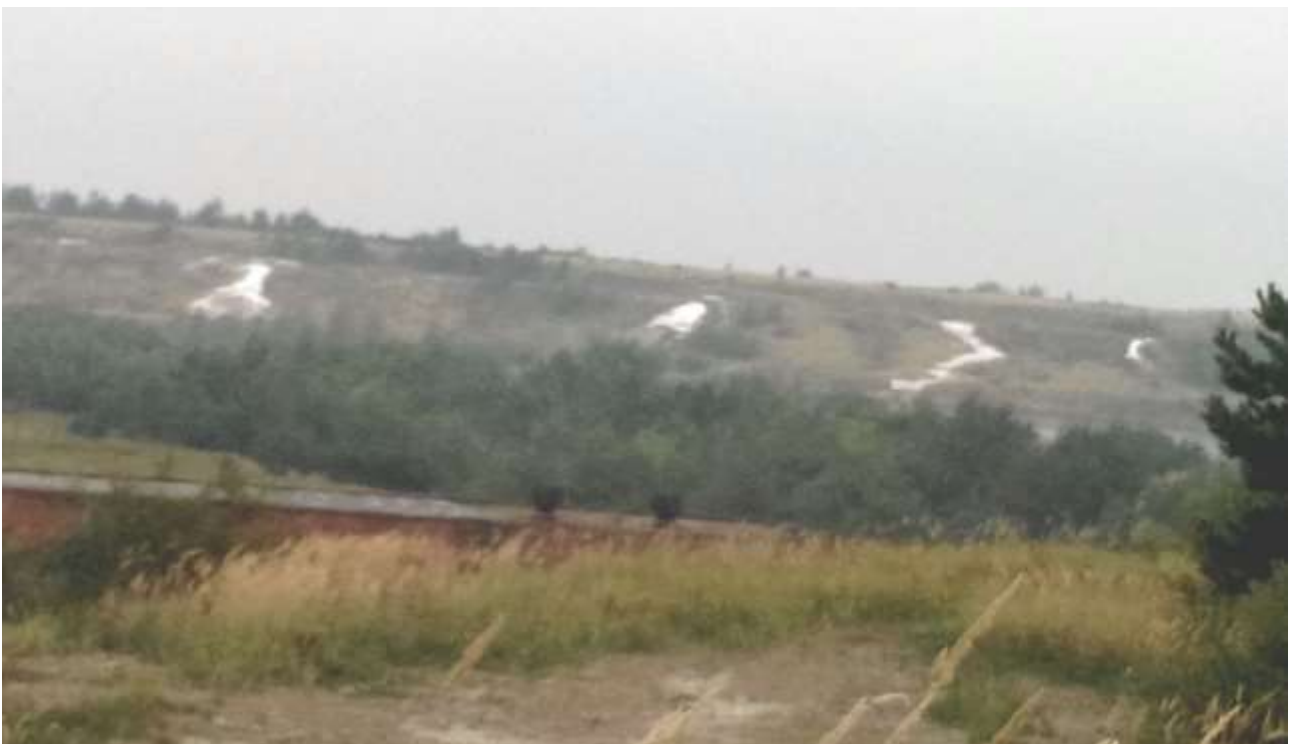
Figure A8.12: External slopes of the tailings dam. Salt is deposited on the slopes as a result of seepage of mineralized tailings water through the dam body (Photo taken at the TMF near Kalush, Ukraine)

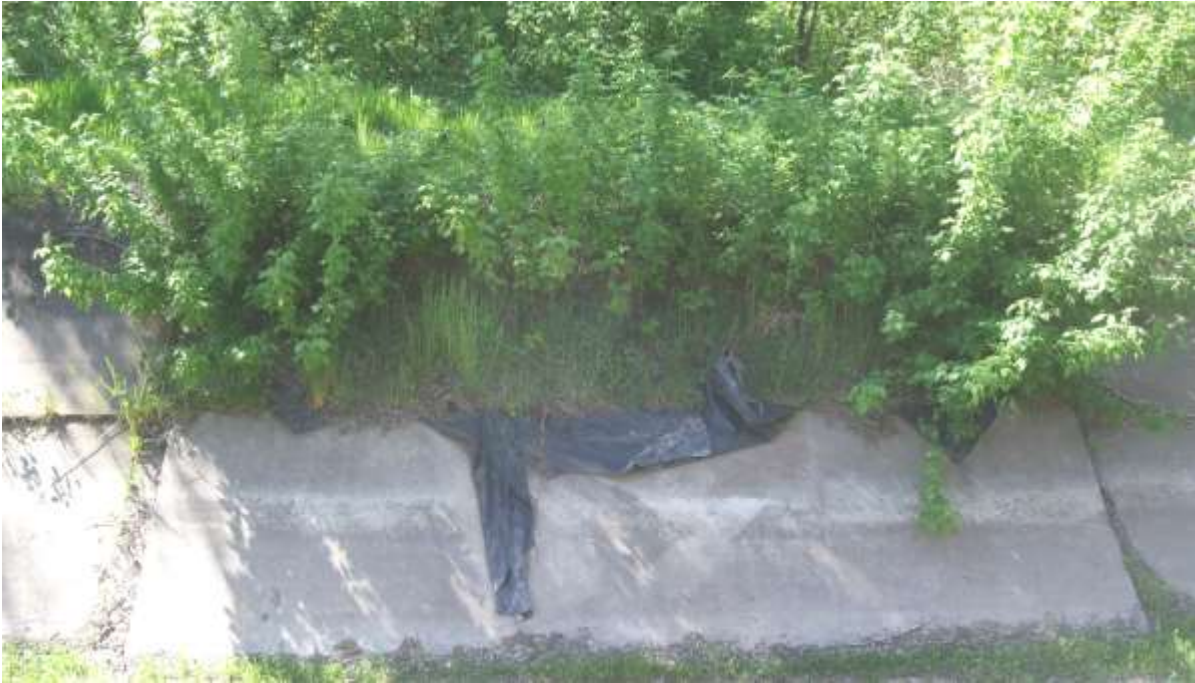
Figure A8.13: Internal part of the tailings dam. Slipping of concrete slabs, exposure and damage of the waterproofing film

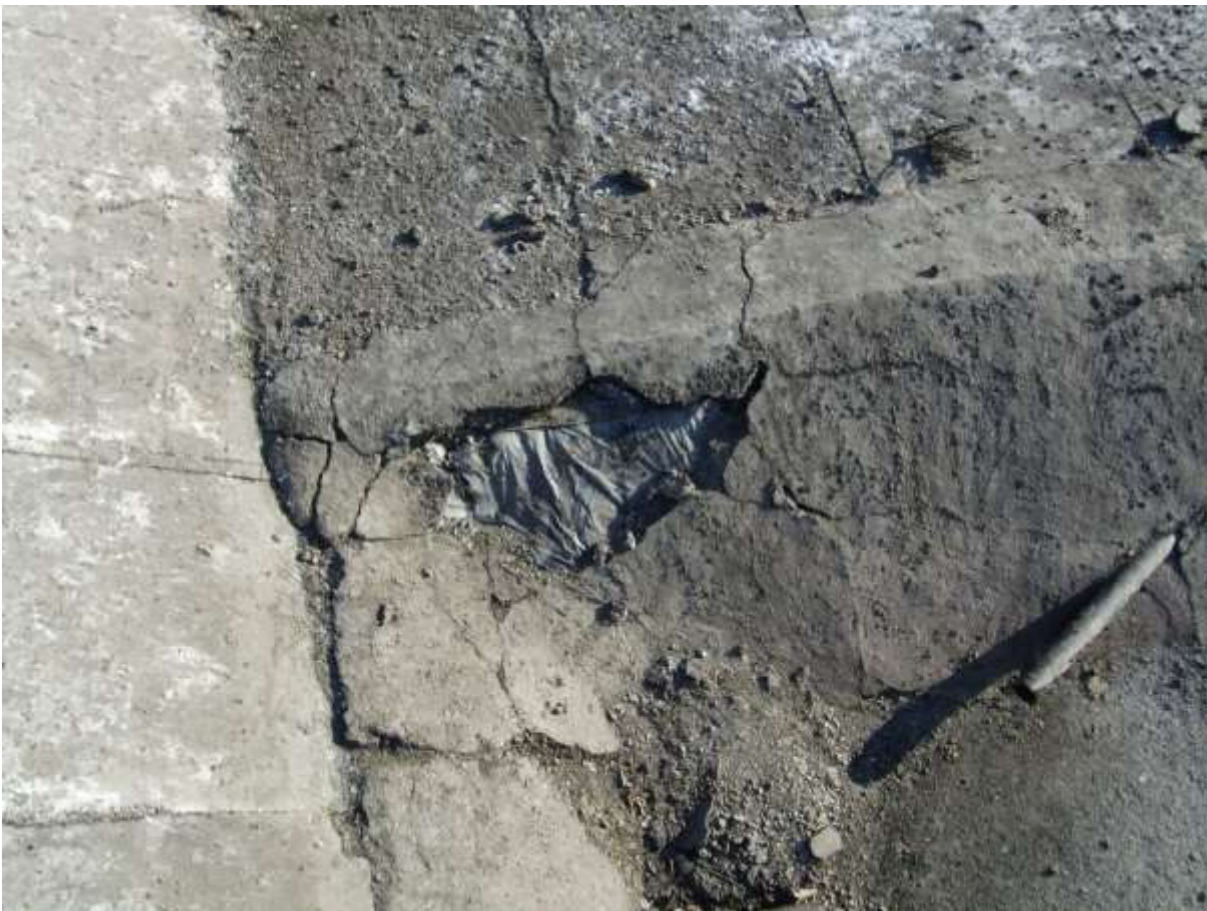
Figure A8.14: Bottom inner part of the tailings dam. Breakthrough of a waterproofing due to destruction of lining.

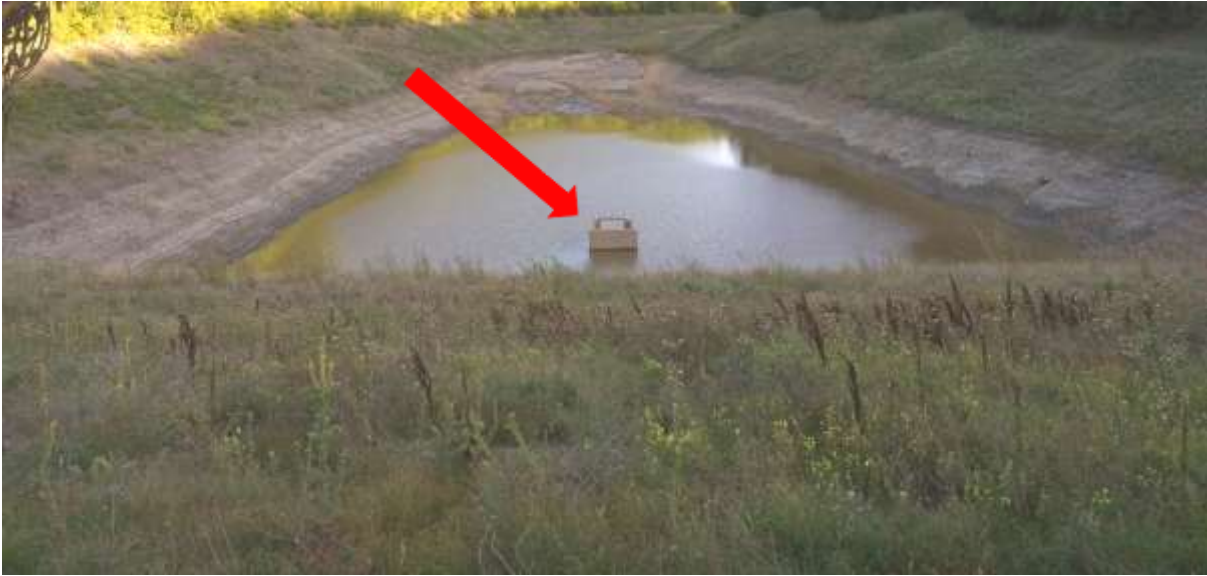
Figure A8.15: Tailings pond. The spillway remains above the water level, which can be interpreted as the implicit sign of leakages from the tailings pond due to permeable waterproofing.

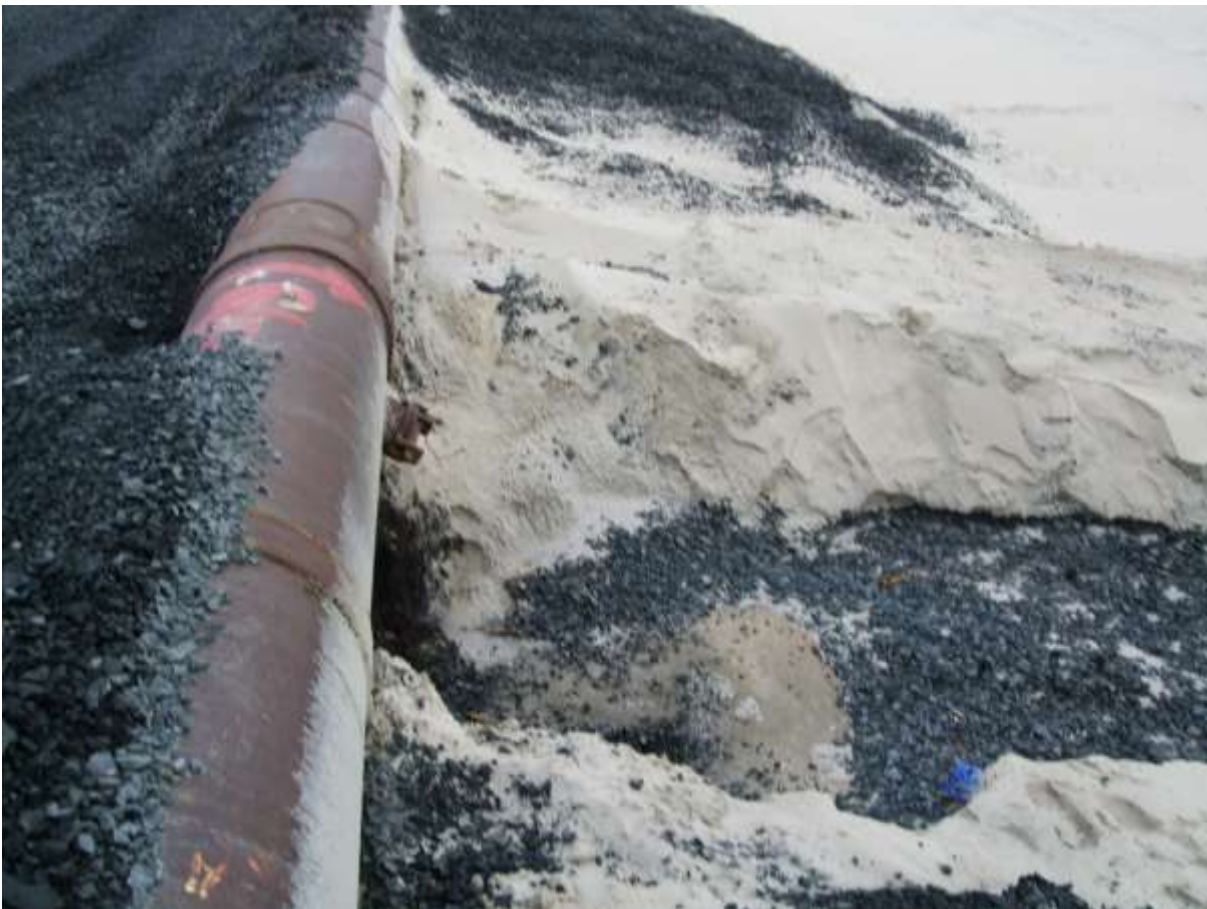
Figure A8.16: External slope of the tailings dam. The promontory arose as a result of uncontrollable surface run-off

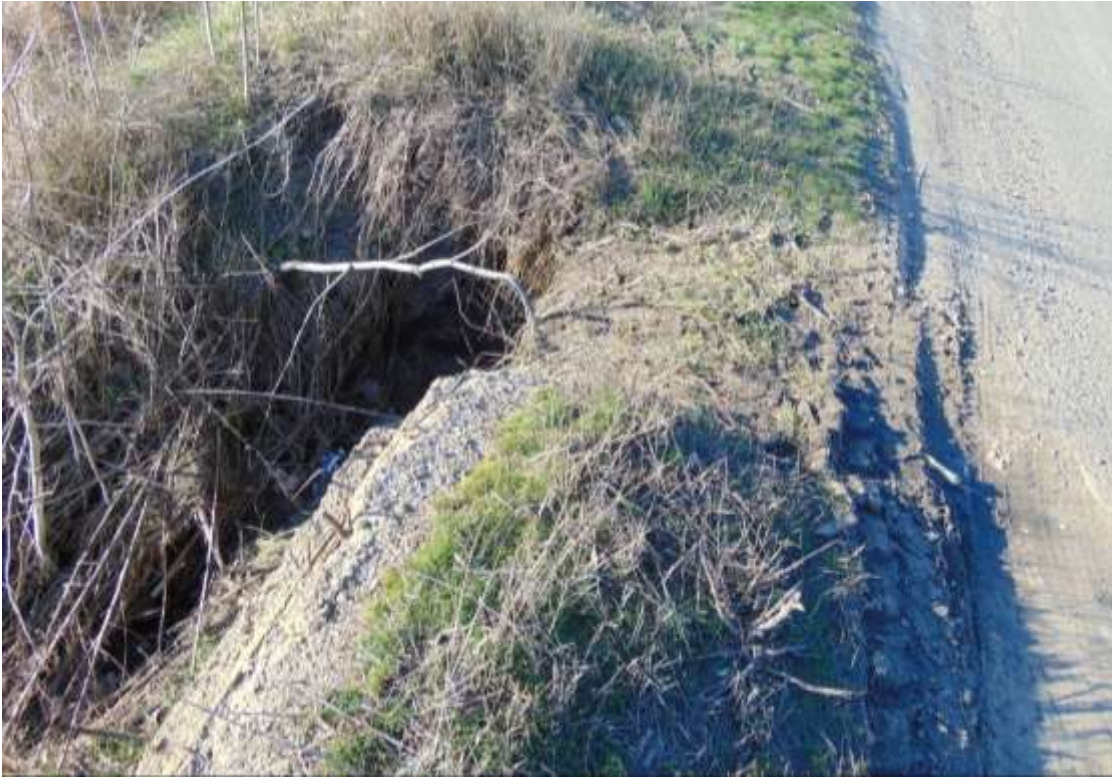
Figure A8.17: External slope of the tailings dam. The promontory appeared as a result of uncontrollable flow of precipitation water

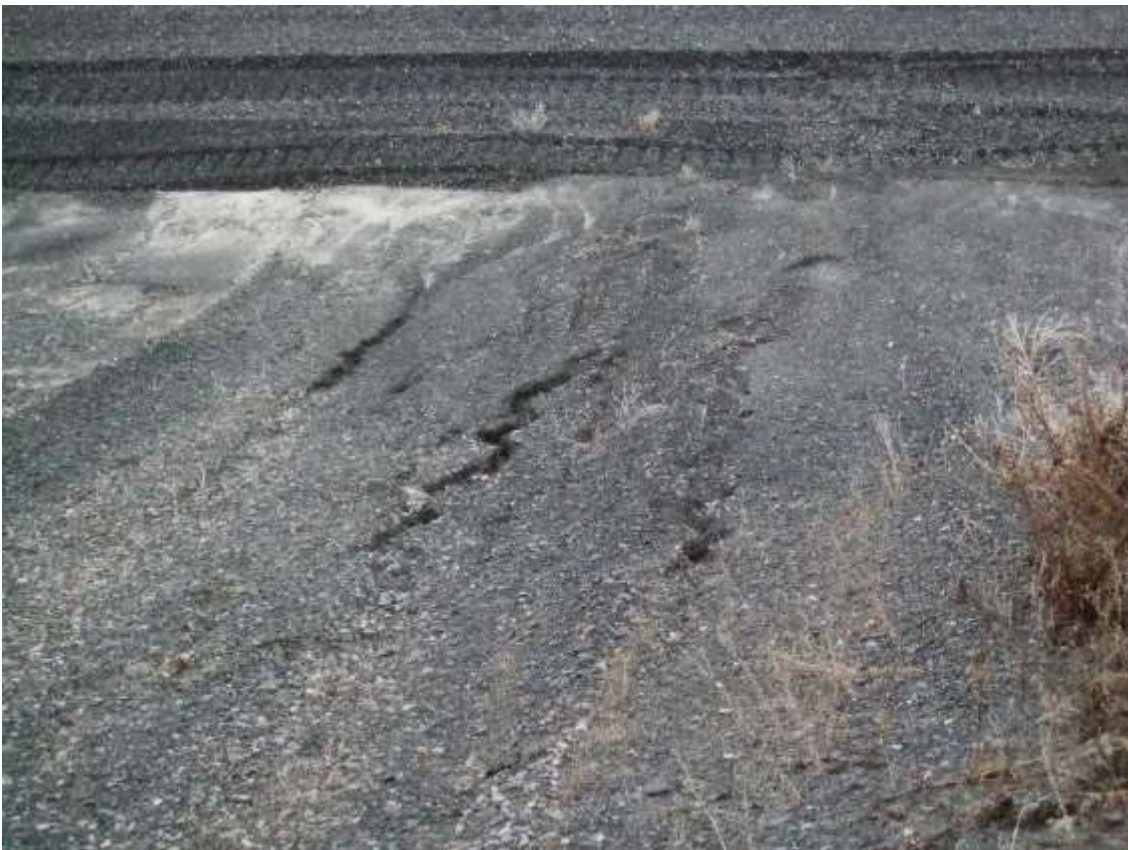
Figure A8.18: External slope of the tailings dam. Small gullies that may become ravines.

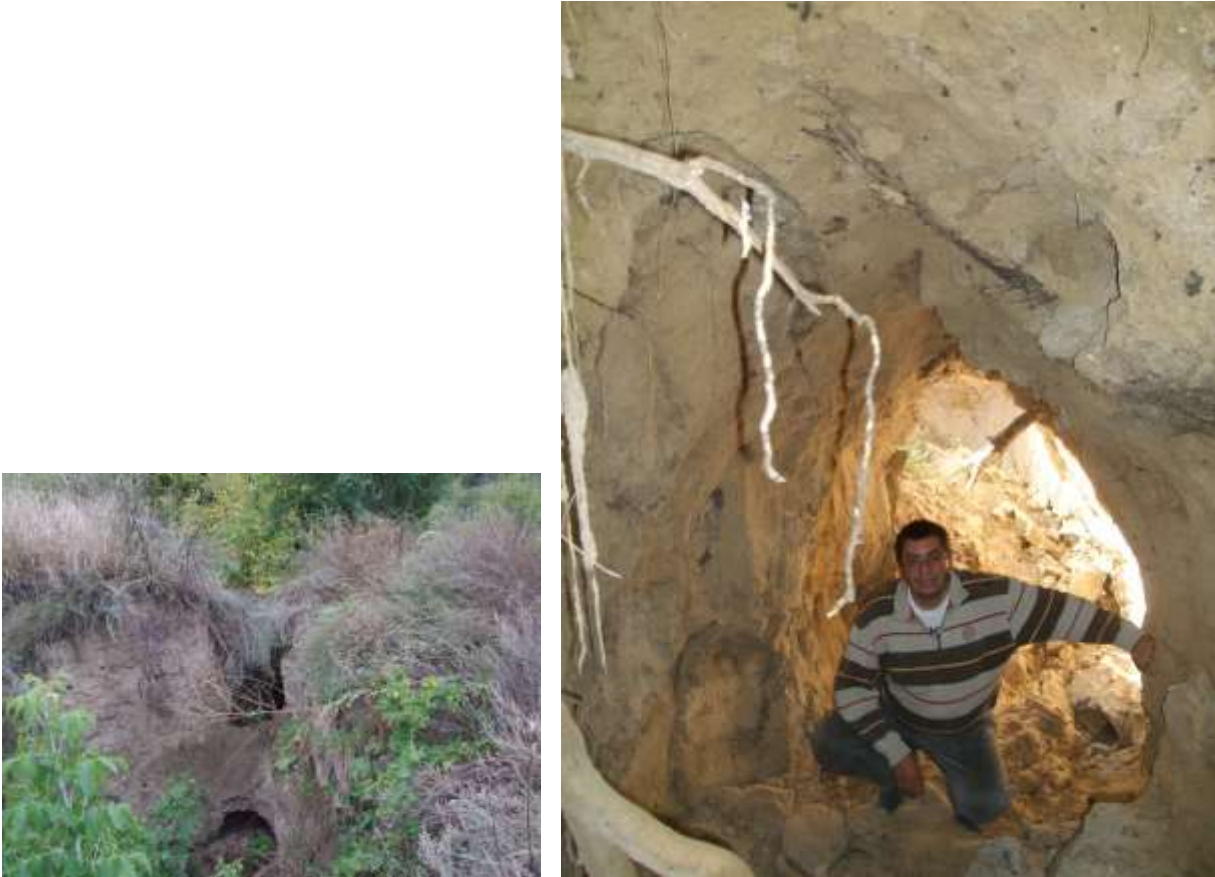
Figure A8.19: The crest and slope of the dam composed of loose materials. The holes of large size in the dam body allow direct inspection.

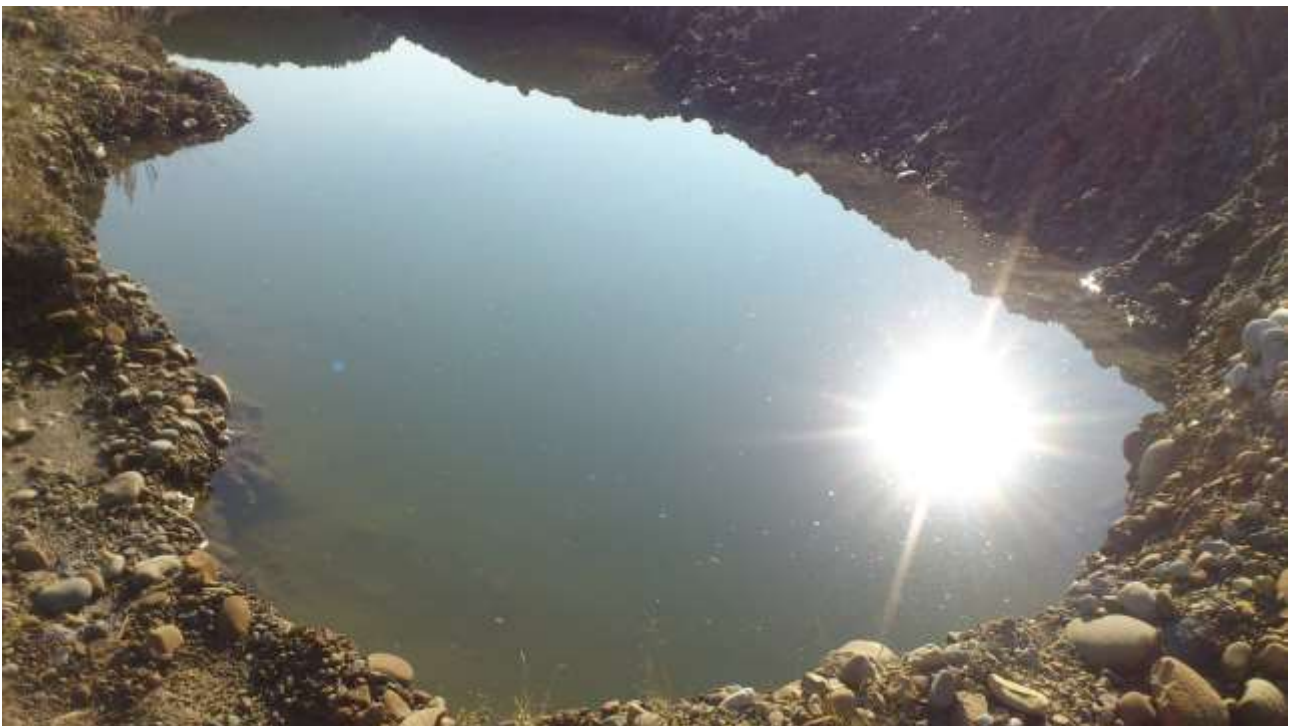
Figure A8.20: The crest of the tailings dam. Salt water accumulation in a poodle on tailings material may lead to suffusion in the dam body

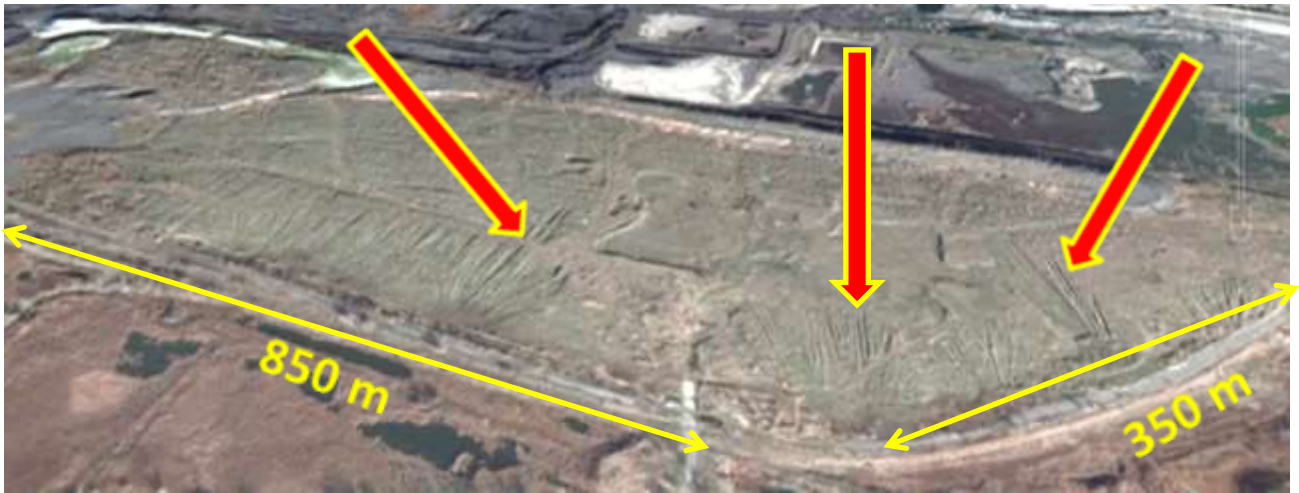
Figure A8.21: A protective screen on the tailing pond with hazardous waste. Linear erosion is caused by atmospheric precipitation. Furrows are formed as a result of incorrect installation of a protective screen by a bulldozer. Precipitation water destroys the screen and accumulates from the inside of the dam, which may lead to its erosion and transport of contaminants to the surface. This is an implicit indication of the poor condition of the tailings pond with serious problems developing in time.

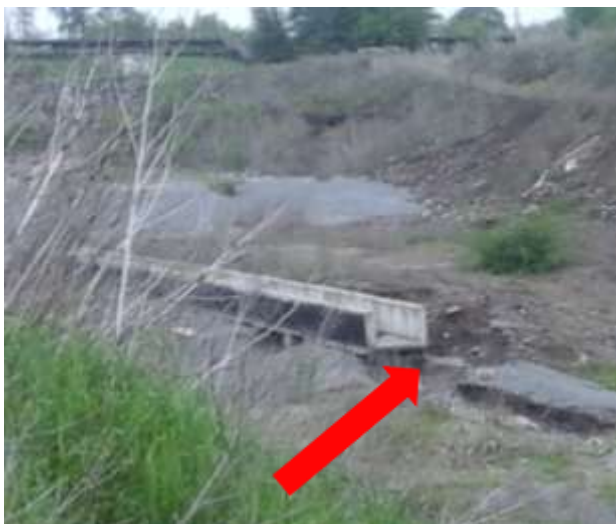
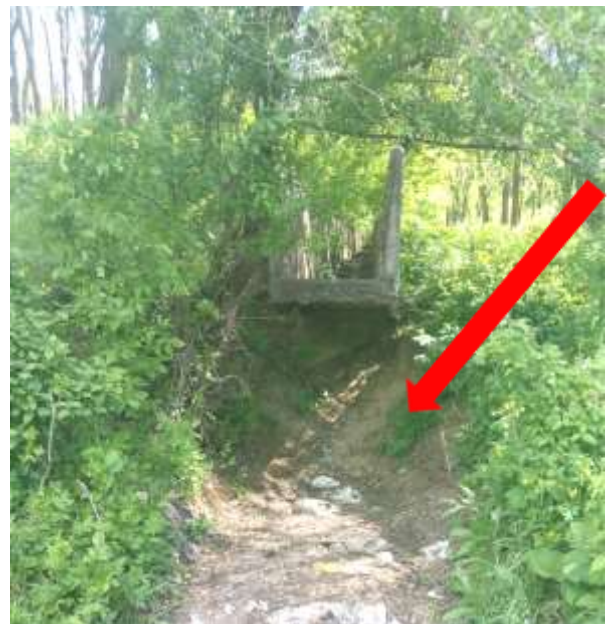
Figure A8.22: Upland drainage ditches and trays. Improper drainage of the tailings causes floor erosion of the talweg of a gully/ravine. The drainage system may be destroyed with further development of erosion

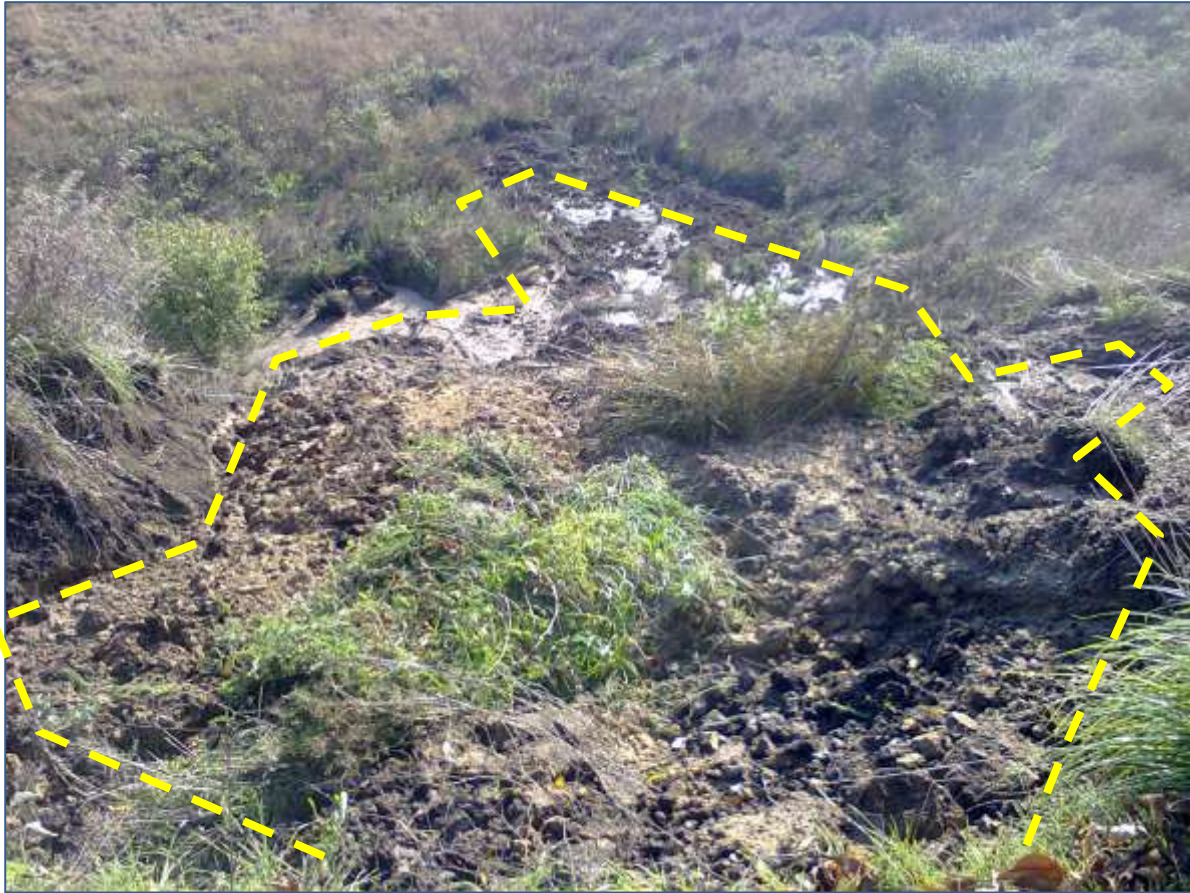
Figure A8.23: External slope of the dam. Moving landslide (mudflow) evidences strong watering of the dam (View from the dam)
