Annex 8. Visual examples of incompliances to TMF safety operation and protective measures

The photos below collected by Prof. D. Pikarenia and Prof. O. Orlinskaya demonstrated safety deficiencies at different parts of the TMF including

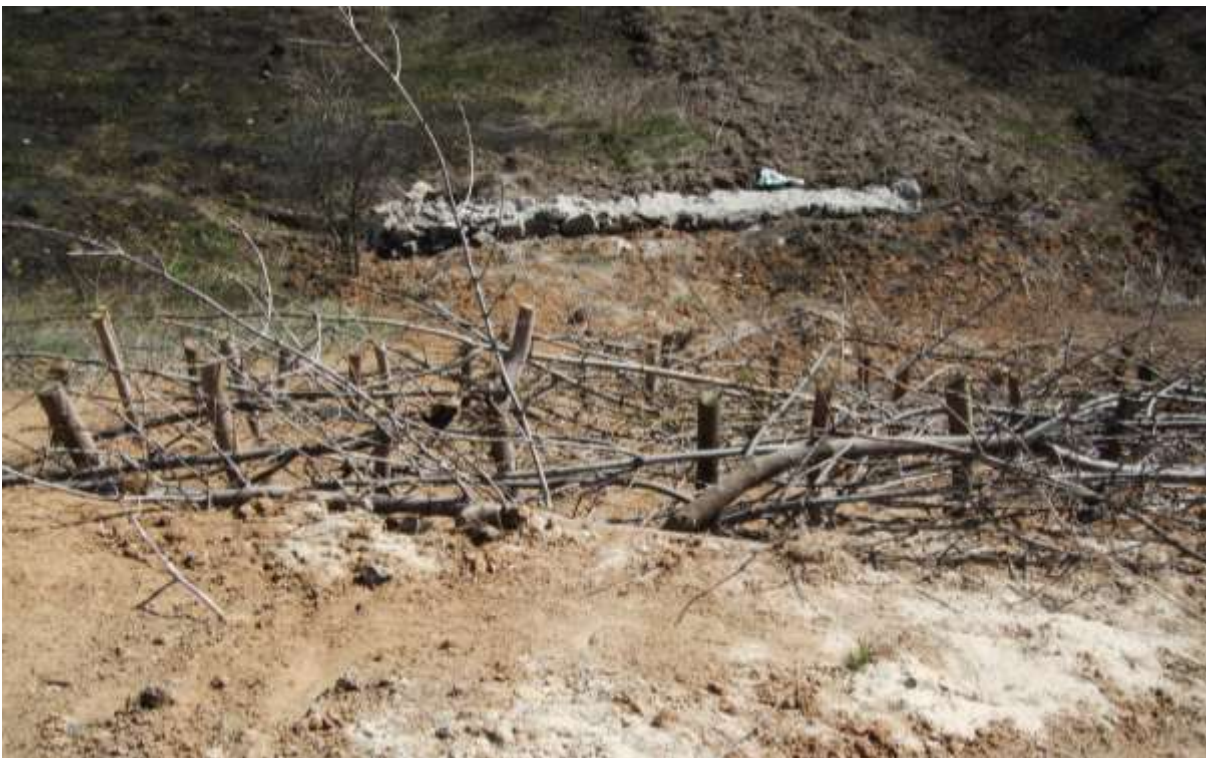
Figure A8.24: The external slope of the dam of an abandoned TMF. The wooden pile series indicate implicitly at a landslide occurred

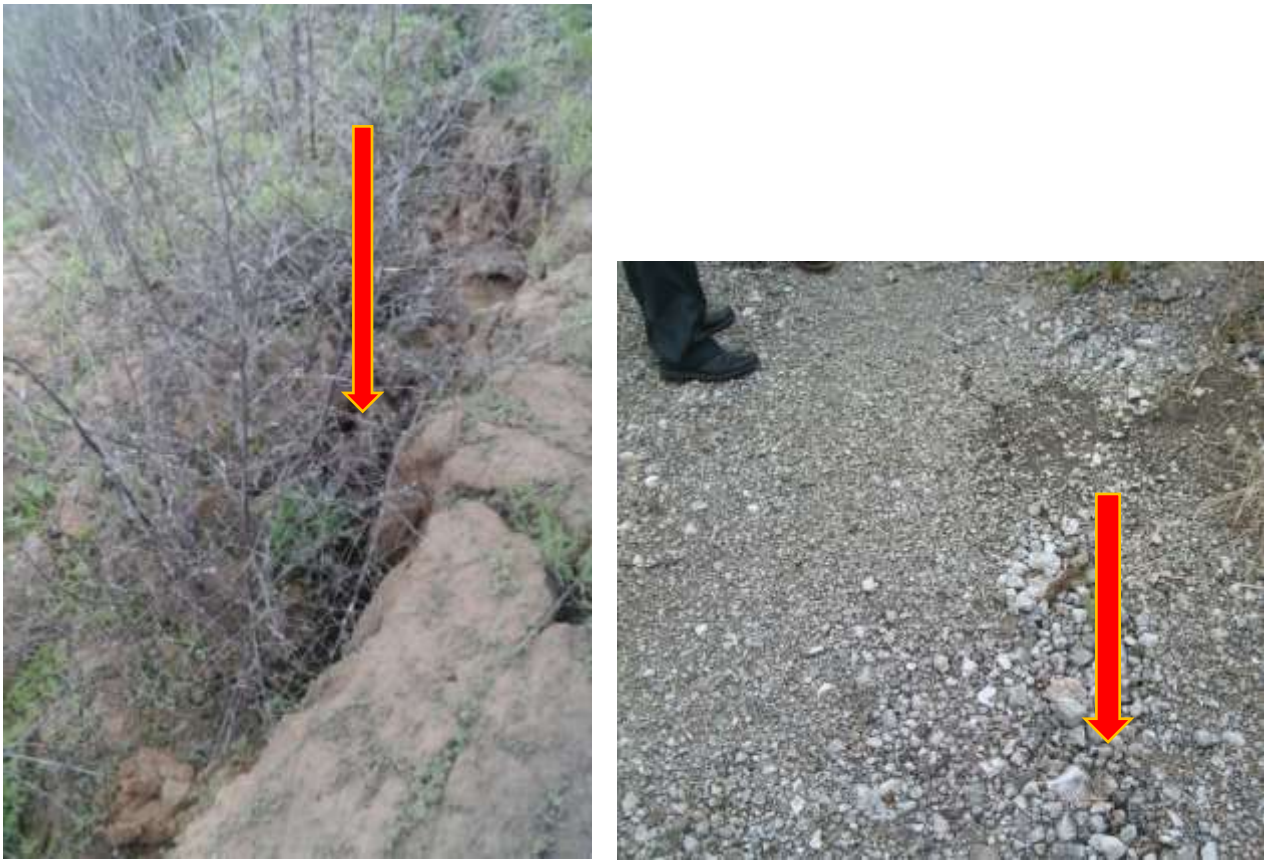
Figure A8.25: The outer side of the tailings dam (left) and the crest of the tailings dam with the break-away gap is an implicit sign of an emerging landslide (right)

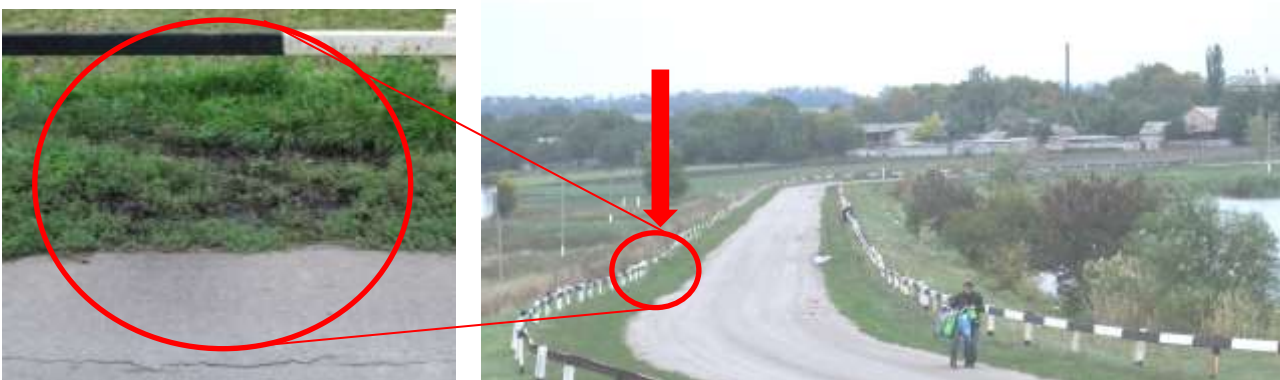
Figure A8.26: External slope of the tailings dam. A rickety road bump and a breakaway in this place implicitly evidence the emerging landslide
